# WILDLIFE TUNNELS UNDER A BUSY, SUBURBAN BOSTON ROADWAY

#### **ABSTRACT**

## **PROJECT HISTORY**

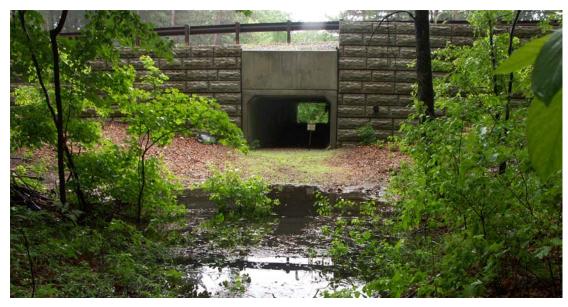
Figure 3. Photograph of underpass # 1

Table 1. Dimensions of four wildlife underpasses in meters and feet, Concord, MA. Height times width divided by length was used to calculate "openness".

Underpass entrances were graded with dirt-covered riprap aprons. Stock-piled material that had been excavated from the site during construction was spread in the structures as substrate to a depth of about 2". To make underpasses less conspicuous and disturbing to wildlife, the retaining wall surface (in the raised sections of highway) had a simulated quarried rock appearance, and native plantings were added at entrances and along the adjacent retaining walls. There was no added fencing for funneling animals into the underpasses or keeping them off the highway. However, there are different types of fencing (including cyclone, wood, barbed wire) of varying heights near residences, playing fields, state highway property, the railroad tracks, and other sections. In places where the roadway is higher than the surrounding land, the retaining walls partly block wildlife movement onto the roadway. The underpasses and other road construction were completed in the fall of 2005, after which we began evaluating monitoring techniques.

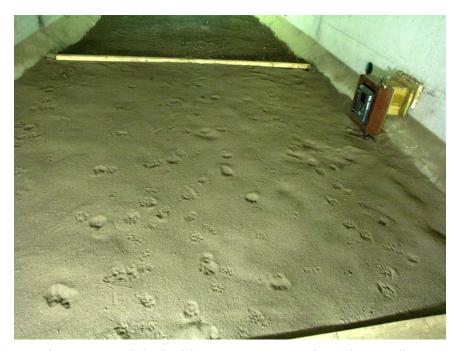
Figure 4. Track bed with Reconyx camera in underpass # 1.

A tracking bed was made in one underpass by sifting the dirt substrate through wire screening onto black plastic between two 2" by 4" boards to a depth of about ½". When dry, this fine, sandy dirt proved to be very good for registering tracks. The bed was in the center of the underpass, the width of the tunnel floor and about 10' long. See Figure 4. Usually two experienced trackers read the track bed twice weekly. The bed was visited 158 times between January 2006 and June 2008. We recorded species, direction of travel, location within the track bed and degree of certainty. When necessary, tracks were identified to a group of species, e.g., "small mammal" for mice and vole, or "weasel" for both long- and short-tailed weasel. Unidentifiable tracks were noted. We "erased" the track bed after each reading with a synthetic duster. The track bed and tracks of interest were photographed for future reference. There was a track bed in only one underpass (#1).

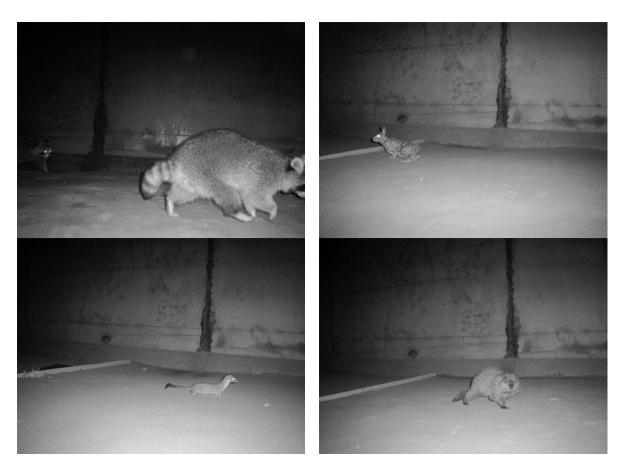
Figure 5. Images from Sony P41. Clockwise from top left: two raccoons, cottontail rabbit, woodchuck, and long-tail weasel.

We tested several camera models and configurations to find the most reliable way to record photographic images of the animals while they registered tracks in the bed at the same time. The first model was a homemade unit using a Sony P41 camera and Pixcontroller (www.pixcontroller.com) pyroelectric infrared sensor, or "PIR" sensor. The camera was modified with an infrared filter to eliminate the white flash. The unit captured very high quality images, but the relatively slow triggering time caused many misses. See Figure 5. Modification with an external power source (6V battery) improved trigger speed by enabling the camera to run in an "always on" mode. However, replacing and charging the battery weekly was labor intensive, and the camera still missed many animal crossings. The Leaf River Model iR-3BU Infrared Digital Game Camera as tested in the underpass lacked sufficient illumination and also missed most passages.

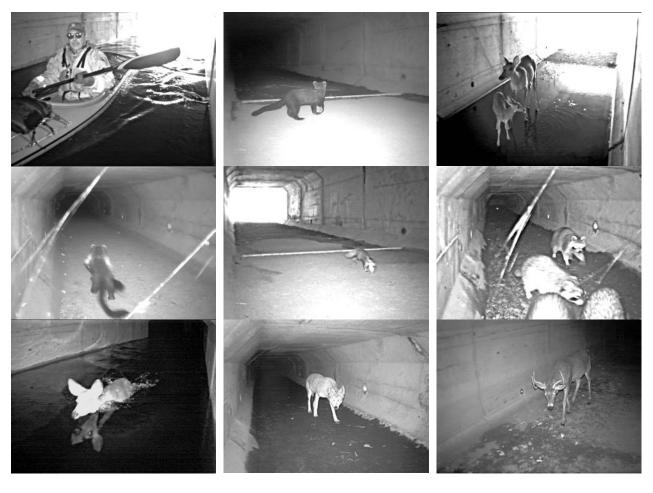
Figure 9. Reconyx photos from within four underpasses, Concord, MA. By row, left to right: kayaker, fisher, doe and fawn, fisher with skunk, gray squirrel with leaf, raccoon family; swimming deer, coyote, and buck.

On the other hand, the monitoring results indicate that wildlife species present in the remnant patches of land close to Route 2 are surprisingly adept at dealing with the highway and human-impacted landscape. Photographic images suggest that wildlife are successfully incorporating the underpasses in their activities and linking parts of their home range. Raccoon were usually photographed in pairs and larger family groups. Photographs record unexpected crossings, such as coyote using even the smallest, 3' by 5' (# 2), underpass. Deer often moved in small groups. Two different bucks were photographed using the same underpass in one season. A doe and her fawn were repeatedly photographed together in one underpass. In an amazing display of fidelity to a flooded underpass, a deer swam through, upstream. A fisher was photographed carrying prey to one side of the road June to September, presumably to a den. Fisher, red fox and raccoon marked with scent inside the underpass and at the entrances. One industrious gray squirrel traveled back and forth, leaf by leaf, to build a nest on the other side of the road. See Figure 9.
